Contract #: 04-0120F4Cty: SF/ALA Rte: 80 PM: 13.2/13.9File #: 1.28**WELDING INSPECTION REPORT****Resident Engineer:** Pursell, Gary**Address:** 333 Burma Road**City:** Oakland, CA 94607**Report No:** WIR-000383**Date Inspected:** 28-Aug-2007**Project Name:** SAS Superstructure**OSM Arrival Time:** 700**Prime Contractor:** American Bridge/Fluor Enterprises, a JV**OSM Departure Time:** 1530**Contractor:** American Bridge/Fluor Enterprises, a JV**Location:** Benicia, CA**CWI Name:** Michael Johnson**CWI Present:** Yes No**Inspected CWI report:** Yes No N/A**Rod Oven in Use:** Yes No N/A**Electrode to specification:** Yes No N/A**Weld Procedures Followed:** Yes No N/A**Qualified Welders:** Yes No N/A**Verified Joint Fit-up:** Yes No N/A**Approved Drawings:** Yes No N/A**Approved WPS:** Yes No N/A**Delayed / Cancelled:** Yes No N/A**Bridge No:** 34-0006**Component:** Procedure Qualification Record (PQR) Test**Summary of Items Observed:**

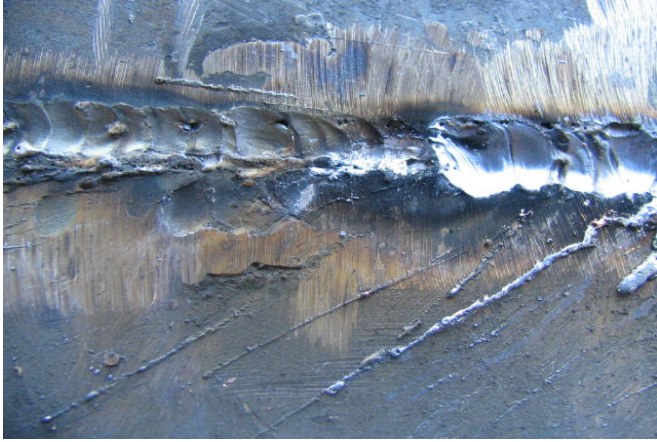
Later in the Shift the QA Inspector observed the root pass deposited onto (3) non-PQR test plates. These non-PQR test plates were ran in order to set the welding parameters and evaluate the root area. The backing bar was removed from these non-PQR test plates by carbon arc cutting (COC) in order to assess the root area. It was observed that after the backing bar was removed several indications were found. See the photo on the left for additional information.

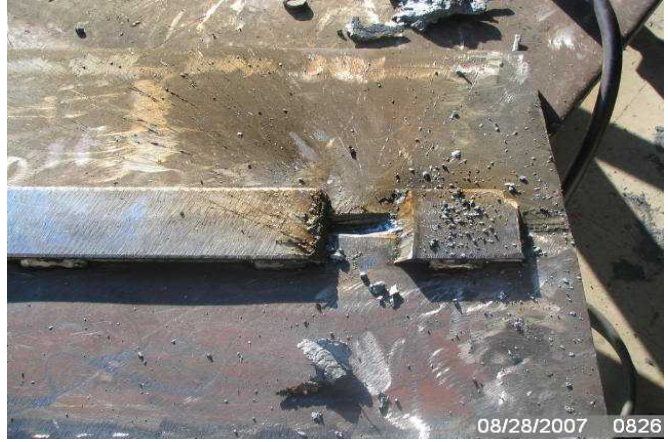
At the beginning of the shift the QA Inspector observed the QC Inspector perform informational UT on the PQR plate known as ABF-PQR-003-1A and the QC Inspector evaluated several indications identified in this PQR test plate. It appears ABF decided to remove a portion of the backing bar of the PQR test plate mentioned above to determine the nature of the indications found by UT. The location where the backing bar was removed is approximately (70) millimeters in length and is 160 millimeters from the start of the weld. Upon removal of the back-up bar the QC Inspector did find several round indications (porosity) of various sizes. This PQR test plate will not be Radiographically Tested (RT). See the photo on the right below for additional information.
